Damage Identification Study of a Seven-story Full-scale Building Slice Tested on the UCSD-NEES Shake Table

Moaveni, B., He, X., Conte, J.P., and Restrepo, J.I. (2010). "Damage identification study of a seven-story full-scale building slice tested on the UCSD-NEES shake table." *Structural Safety*, Volume 32, Issue 5, Pages 347-356.

DAMAGE IDENTIFICATION STUDY OF A SEVEN-STORY FULL-SCALE BUILDING SLICE TESTED ON THE UCSD-NEES SHAKE TABLE

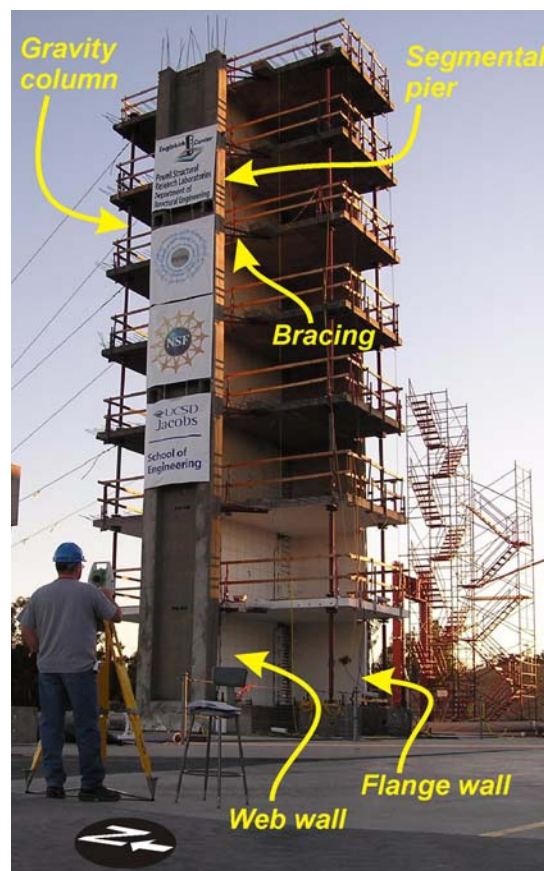
The test structure which represented a section of a full-scale reinforced concrete wall building consisted of a main wall (web wall), a back wall perpendicular to the main wall (flange

wall) for transversal stability, a concrete slab at each floor level (except at the base), an auxiliary post-tensioned column to provide torsional stability, and four gravity columns to transfer the weight of the slabs to the shake table platen. Slotted slab connections were placed between the web and flange walls at floor levels to minimize the moment transfer between the two walls, while allowing the transfer of the in-plane diaphragm forces. Figures 1 shows the building mounted on the shake table. More details about the building can be found in [12, 13].

Fig. 1 Test structure

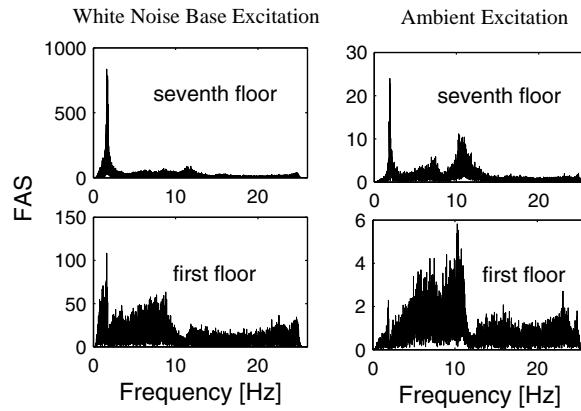
In this study, data from 14 longitudinal acceleration channels (on the web wall at each floor level and at mid-height of each story) were used to identify the damage at different states of the building. The measured acceleration responses were sampled at a rate of 240Hz resulting in a Nyquist frequency of 120Hz, which is much higher than the modal frequencies of interest in this study (< 25Hz). These measured data were band-pass filtered between 0.5Hz and 25Hz using a high order (1024) FIR filter. Figure 2 shows the Fourier Amplitude Spectra (FAS) of two filtered acceleration time histories recorded at floor levels 1 (first floor above the table) and 7 (roof) during a 0.03g RMS white noise base excitation test (left column) and an ambient vibration test (right column) performed on the building in its undamaged state. From this figure, it is observed that: (1) the FAS plots are very jagged/noisy which may be due to rattling of many loose connections especially from the slackness between the threaded rod and the nut in the gravity columns (1.5 mm of slackness) when they go from tension to compression or vice versa as well as the slackness at both ends of the steel braces connecting the slabs to the post-tensioned column; (2) the first longitudinal vibration mode has a predominant contribution to the measured response, especially at the higher floors, which renders the identification of higher (than the first longitudinal) modes more difficult; and (3) the FAS of the acceleration response histories at the first floor appear to have a drop in amplitude at around 11.5 Hz which is due to the application of a notch filter in the

Fig. 2 Fourier Amplitude Spectra of acceleration response measurements at the first and seventh (roof) floors due to 0.03g RMS white noise base excitation (left) and ambient excitation (right)

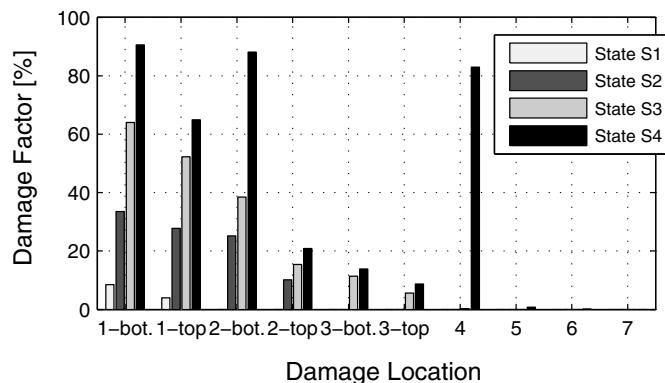
In this case of damage identification, once the reference model is obtained, 10 updating parameters (corresponding to 10 substructures) are updated from the reference FE model (at the undamaged/baseline state S0) to states S1, S2, S3.1, and S4. These 10 substructures represent the web wall, 6 along the first three stories (two per story) and 4 along the higher stories (one per story) as shown in Figure 4(b). The values of the stiffness parameters of the remaining substructures are kept fixed at the corresponding values in the reference FE model. For each of the considered states of the building, the natural frequencies and mode shapes of the first three longitudinal vibration modes are used in the objective function for damage identification, resulting in a residual vector with 42 components (i.e., 3 natural frequencies and 3 vibration mode shapes with $14 - 1 = 13$ components each).

Fig. 5 Identified damage factors at various substructures for damage identification Case I (based on ambient vibration data)

In updating the FE model at each considered damage state of the building, the k^{th} dimensionless damage factor was constrained to be in the range $[\mathbf{a}_0^{\text{Si}}(k), 0.95]$, with $\mathbf{a}_0^{\text{Si}}(k)$ denoting the initial value of the damage factor of the k^{th} substructure at states $\text{Si} = \text{S1}, \text{S2}, \text{S3.1}, \text{S4}$. At each

state considered, the vector of initial damage factors \mathbf{a}_0^{Si} , used as starting point in the optimization process, was selected as the damage factors identified at the previous damage state or zero for state S1. The upper-bound of 95% was selected based on the observed damage in the building, while the lower bound of $\mathbf{a}_0^{\text{Si}}(k)$ was selected considering that the identified effective moduli of elasticity are not expected to increase with increasing damage. The damage factors (relative to the reference FE model or reference state) obtained at different damage states are presented in a bar plot in Figure 5. These results indicate that: (1) the severity of structural damage increases as the building is exposed to stronger earthquake excitations; and (2) the extent of damage decreases rapidly along the height of the building (damage concentrated in the two bottom stories), except for a false alarm in the fourth story at state S4. This large identified damage factor in the fourth story may be due to the facts that (1) the updating parameters (effective moduli of elasticity of substructures) account for the effect of damage in other non-updating elements such as the floor slabs, flange wall, post-tensioned column and the connections between floor slabs and post-tensioned column, and (2) the identified damage factors at state S4 are in general characterized by a higher level of estimation uncertainty than at the previous (lower) damage states. The higher damage estimation uncertainty at state S4 is due to the following facts. (i) With increasing level of structural damage, the level of nonlinearity in the structural response increases. Therefore, the assumption that the building behaves as a quasi-linear dynamic system is violated and a linear dynamic model (modal model) is not strictly able to represent well the building, i.e., the modeling error in state S4 is the largest (see Table 5). (ii) The optimization algorithm used is not a global optimization algorithm and the probability to converge to a local minimum (which is not the global minimum) increases with increasing difference between the identified modal parameters at

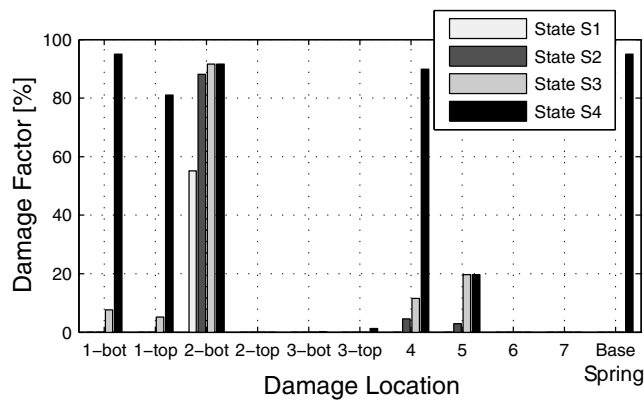
In the second case of damage identification, 11 updating parameters (corresponding to 11 substructures) are updated from the reference FE model (at state S0) to states S1, S2, S3.1, and S4. These 11 substructures include the same 10 substructures used in the first case of damage identification, i.e., 6 along the first three stories (two per story) and four along the higher stories (one per story) of the web wall, and one additional substructure consisting of a rotational spring at the base of the web wall to model the flexibility of the shake table system and the rotation at the base of the web wall due to bond slip of the longitudinal reinforcing bars. As already mentioned, the rotation of the base of the web wall played a non-negligible role in the response of the building during the white noise base excitation tests, but was not significant in the ambient vibration tests which were of very low amplitude. At each damage state, the initial damage factors used as starting point in the optimization process are taken as the identified damage factors for the previous damage state or zero for state S1. In updating the reference FE model to states S1 through S4, the dimensionless damage factors were constrained to be in the range $[\mathbf{a}_0^{\text{Si}}(k), 0.95]$ as in Case I. The identified damage factors (relative to the reference state S0) obtained for the web wall and base spring at the various damage states considered are presented in bar plot in Figure 6. These results indicate that: (1) the severity of structural damage increases with the intensity of the earth-

quake excitation; (2) at each damage state, the most severe damage is identified at the first story (top and bottom) and second story (bottom) of the web wall. However, at state S4, severe damage is spuriously identified at the fourth story. The possible explanations for this falsely identified damage factor are the same as in Case I. (3) The rotational spring at the base of the wall is significantly damaged at state S4 due to the development of significant bond-slip in the longitudinal reinforcing bars of the web wall (anchored in the foundation beam) at this damage state.

Fig. 6 Identified damage factors at various substructures for damage identification Case II (based on 0.03g RMS white noise test data)

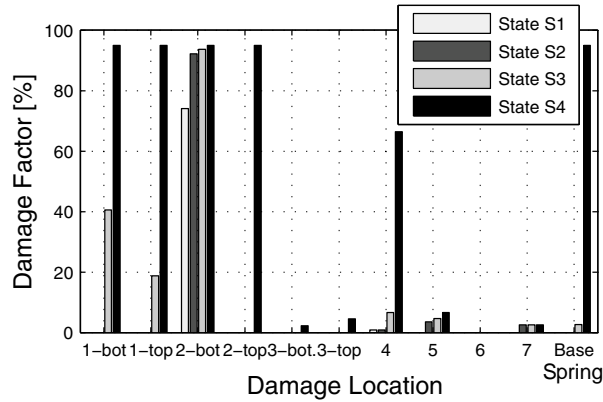
In the third damage identification case, the same 11 updating parameters used in the previous case are updated at each of states S1, S2, S3.1, and S4. As mentioned earlier, the 0.05g RMS white noise base excitation test was not performed at state S0, therefore the reference FE model calibrated based on the 0.03g RMS white noise test data was used as reference model in this case. In updating the reference FE model to states S1 through S4, the dimensionless damage factors were constrained to be in the range $[\mathbf{a}_0^{Si}(k), 0.95]$ as in the previous cases. The identified damage factors (relative to the reference state) obtained for the web wall and floor slabs at various damage states are presented in bar plot in Figure 7. The results are very similar to those obtained in Case II except for the large damage factor identified at the top of the second story at state S4. This large damage factor may be due to parameter compensation effects, since the effective stiffness of sev-

Fig. 7 Identified damage factors at various substructures for damage identification Case III (based on 0.05g RMS white noise test data)

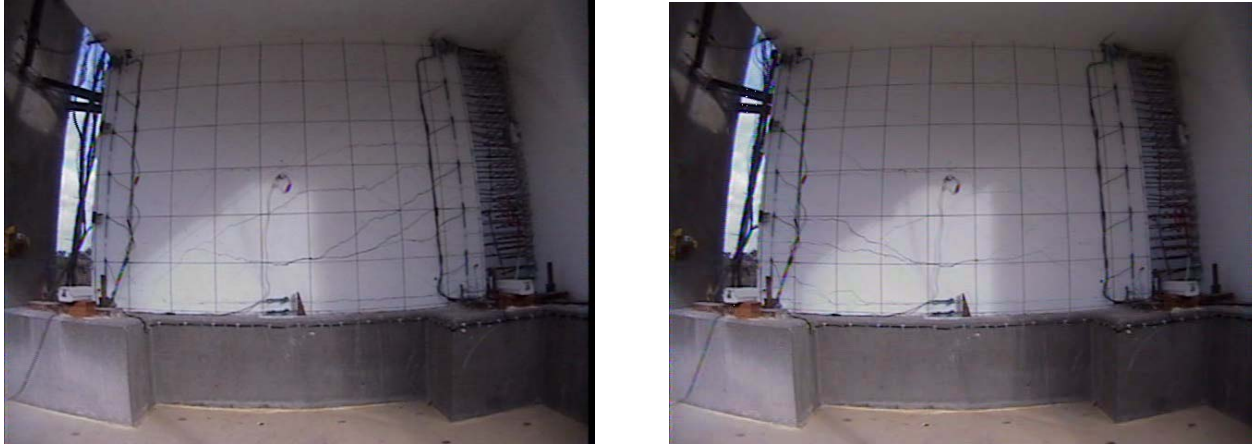
Fig. 8 Extent of flexure-shear cracking at the first story (plastic-hinge region) of the web wall during EQ4 (at instants of time near maximum base rotation)

Pictures of the actual damage at the bottom two stories of the web wall at state S4 are shown in Figures 8 through 10. Figures 8 and 9 show a combination of flexure (horizontal) and flexure-shear (inclined) cracks at the first story of the web wall during the seismic test EQ4 (at

instants of time near the maximum base rotation of the web wall). These two figures correspond to two frames taken from two digital movies recorded during seismic test EQ4. During the seismic test EQ4, a lap-splice failure (i.e., debonding between longitudinal steel reinforcement bars and the surrounding concrete) occurred in the web wall at the bottom of the second story on the west side as shown in Figure 10. Figure 11 shows the tensile strain envelopes for the concrete (left) and the longitudinal reinforcement (right) along the first two stories of the web wall over the duration of each of the four seismic tests. The concrete and reinforcement tensile strains were measured using LVDTs and strain gages, respectively. Figures 8 to 10 together with the concrete and longitudinal reinforcement tensile strain envelopes in Figure 11 provide a physical observation/measure of the damage in the wall. The damage identification results obtained in all three cases are consistent with the concentration of actual damage at the bottom two stories of the web wall. However, only in Case I of damage identification, significant loss of stiffness has been identified along the web wall at states S1 and S2. The differences in the identified damage results obtained from the different cases can be due to a number of reasons: (1) different sets of identified modal parameters are used in the three cases, each with a different level of estimation uncertainty; (2) varying degree of modeling error: the assumption of a quasi-linear dynamic system is progressively violated with increasing level of excitation (the ambient vibration data satisfy better the assumption of system linearity and therefore are more appropriate as input for linear FE model updating); (3) different reference/baseline models are used in the three cases of damage identification; (4) different weights are assigned to the various modal residuals in the three cases (due to different modal parameter estimation uncertainties); and (5) different numbers of updating parameters are used in different cases.

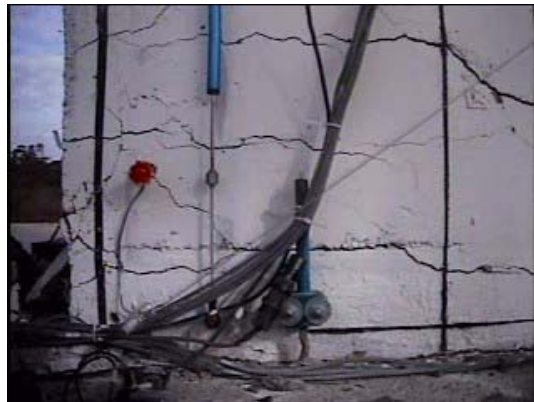
Fig. 9 Extent of flexure-shear cracking at the bottom corner of the first story of the web wall during EQ4 (at instant of time near maximum base rotation)
